ATTACHMENT TO L-1461
7 AUGUST 1966
PAGE 1

PETROLEUM PRODUCTS STORAGE
HAI PHONG, NORTH VIETNAM
2052N 10639E

THIS BRIEFING BOARD DEPICTS STRIKE DAMAGE TO THE HAI PHONG
PETROLEUM PRODUCTS STORAGE.

**PETROLEUM PRODUCTS STORAGE
HAIPHONG, NORTH VIETNAM
20-52N 106-39E**

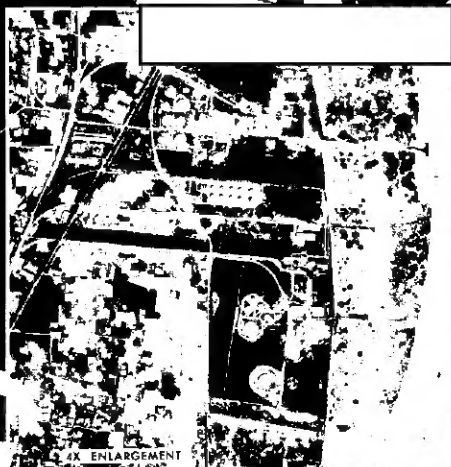
7X ENLARGEMENT
NPIC L-1461 (8/66)

PROBABLE U/G
STORAGE AREA

TANKS DESTROYED THIRD STRIKE
BUILDINGS DAMAGED/DESTROYED
THIRD STRIKE

ACCUMULATIVE ASSESSMENT

23 DESTROYED TANKS
11 DAMAGED TANKS
1 UNDAMAGED TANK

POST-STRIKE PHOTOGRAPHY [REDACTED] REVEALS FIVE
OF THE SIXTEEN PREVIOUSLY DAMAGED TANKS TO BE DESTROYED, RESULTING IN
A TOTAL OF TWENTY-THREE TANKS DESTROYED AND ELEVEN TANKS DAMAGED. ONE
HORIZONTAL SERVICE TANK WAS LEFT APPARENTLY UNDAMAGED.

FOUR BUILDINGS WITHIN THE FACILITY WERE DESTROYED AND ONE WAS
DAMAGED.

NEWLY-IDENTIFIED ON THIS MISSION IS A PROBABLE UNDERGROUND POL
STORAGE AREA ON THE SOUTH BANK OF THE CUA CAM (DISTRIBUTARY) BETWEEN
THE MIDDLE AND EASTERN PIERS. THE AREA CONTAINS AT LEAST FIFTEEN
BURIED PROBABLE TANKS.
